# Ailsworth

## Built Environment Audit 2002/2004

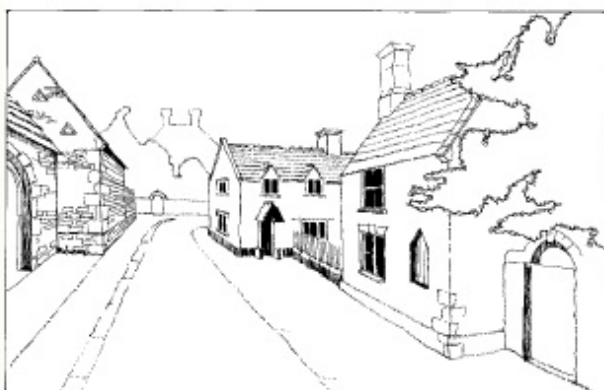
Enclosing Elements were summarised as:

- Buildings - of any size, type or age, make a very positive contribution to the street scene or which clearly detract from it.
- Walls - stone, brick, block or other masonry walls.
- Fences/Railings -
- Trees -
- Other -

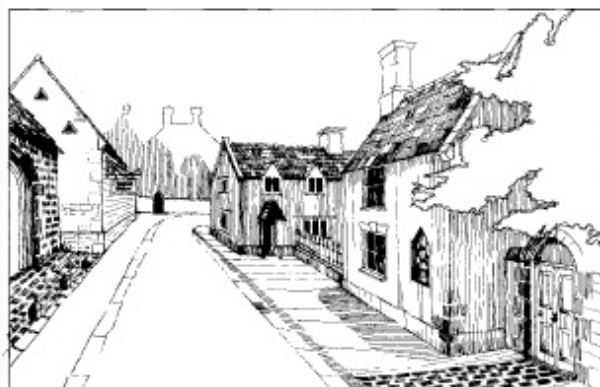
These are the finer parts of the scene, e.g. architectural make-up, local building styles, materials etc., which may brighten and enliven an area, giving it an individual identity, or an unsightly advertisement or road sign, which may spoil a street scene.

- Architectural - striking features of buildings such as decorative chimneys, or moulded door case, or alterations or features, which are obviously out of place in the street scene.
- Street furniture - street lights, bollards, benches etc.
- Advertisements - shop fronts, illuminated and non-illuminated projecting signs etc.
- Floorscape - tarmac, paving, cobbles or specially designed surfaces around trees or steps etc.
- Other -

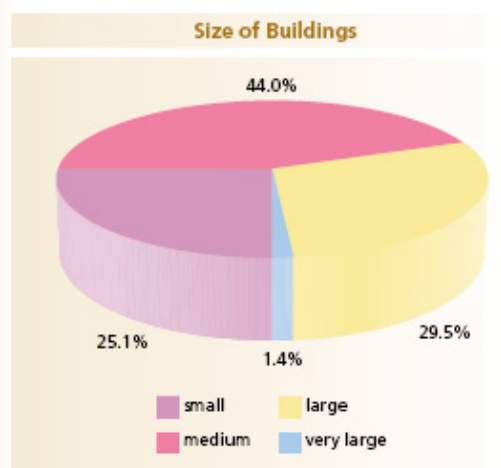
### 4.1.2 Building Size

Most buildings (44%), are medium sized, and most of these are on Helpston Road and the Singerfire Road/Casworth Way/Andrew Close estate.

A quarter of the building stock is small, and clustered to the south of the village on Peterborough Road and Helpston Road.

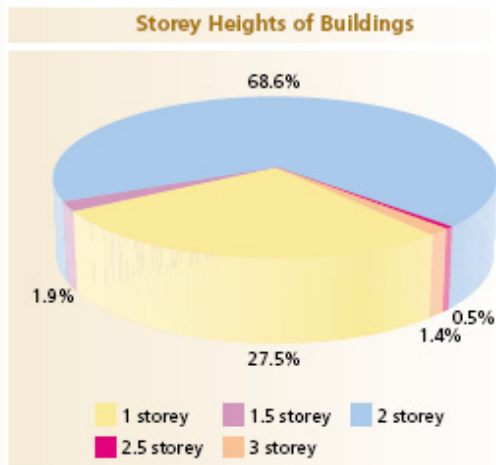
### 4.1.3 Storey Heights

Ailsworth is dominated by two storey buildings. Of the total population of buildings in the village, 69% are two storeys high.

There are fifty seven single storey buildings in the village, equating to 27% of the total number. Most of these are twentieth century bungalows on Helpston Road and the Singerfire Road/Casworth Way/Andrew Close estate.

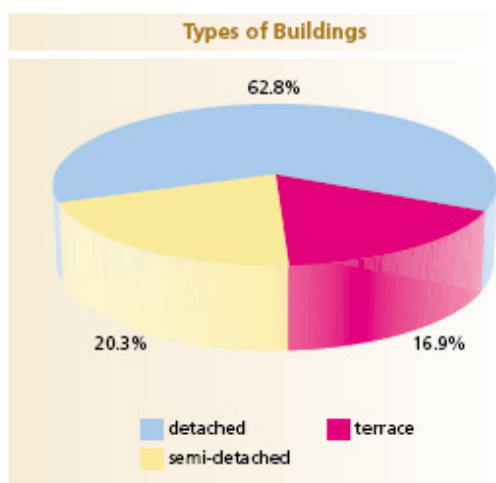
### 4.1.4 Property Types

Detached buildings account for 63% of all properties in the village.

Thirty five or 17% are terraced properties, including end of terraces. Semi-detached properties account for forty two properties or 20% of the village building population.

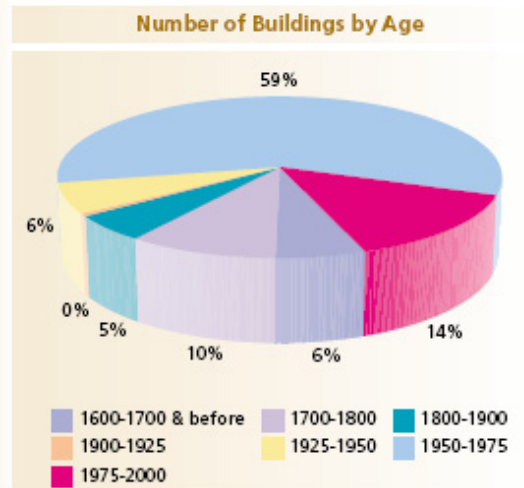
### 4.1.5 Ages of Buildings

More than three quarters of Ailsworth properties (79%), were built during the twentieth century and 74% of these were built between 1950 and 1975. The Singerfire Road/Casworth Way/Andrew Close estate, much of Helpston Road and the majority of infill developments on the west side of Maffit Road were constructed during this period.

Main Street clearly represents the village's historic core, with buildings from the seventeenth, eighteenth and nineteenth centuries. The older buildings on Peterborough Road all date from the nineteenth century.

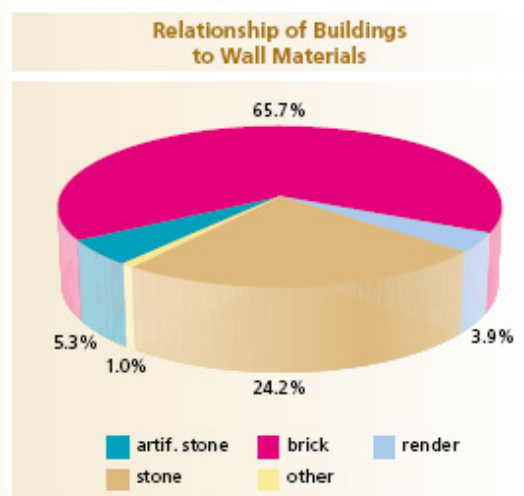
The majority of buildings (66%), are constructed of modern bricks. The next largest category are stone buildings representing 24% of all buildings, with artificial stone making up 5% of the total building stock.

Unsurprisingly, the modern estates and infill housing are almost entirely constructed in modern brick; the Distribution of Wall Materials map very clearly defines the historic core of Ailsworth as the cluster of stone buildings around the north half of Main Street.

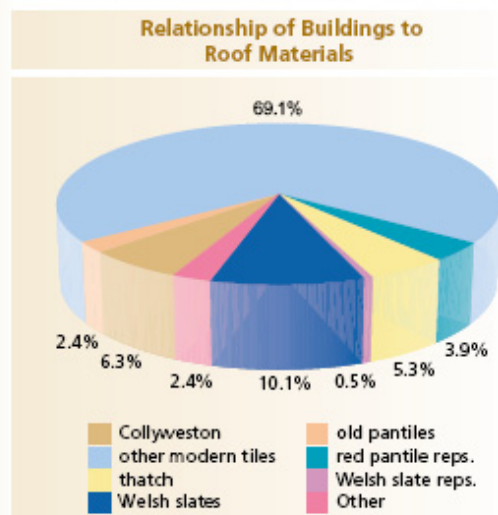
The pie chart shows that modern tiles are the most common roofing material in Ailsworth, accounting for 69% of all properties.

Welsh slate comprises 10% of all roofs, which are notably clustered around Peterborough Road and associated with the nineteenth century buildings.

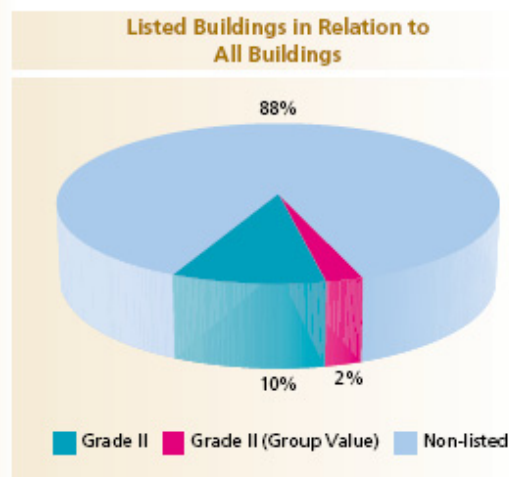
There are twenty three listed buildings in Ailsworth, 11% of the total building stock.

These are all Grade II and occur in two noticeable clusters along Peterborough Road and in the north part of Main Street; hence nineteen of the twenty three buildings are noted as having Group Value.

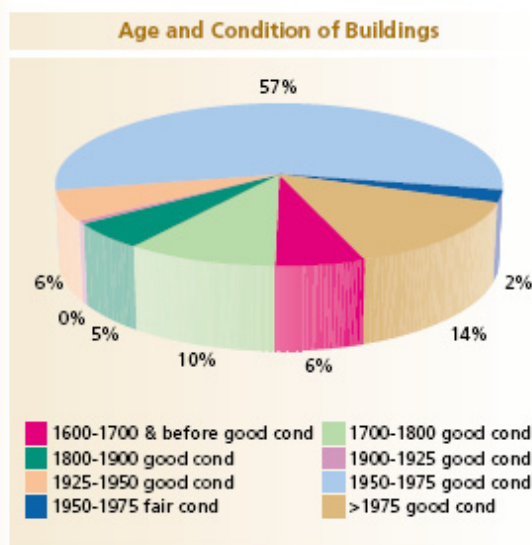
#### Analysis by Age and Condition

Ailsworth does not have many properties that are in a less than good condition. The few that are not in good condition (only four properties from the whole built population of the village), are classed as being in a fair condition.

It is not known if the good condition of the built fabric is due to the general affluence of the Greater Peterborough area, the availability of grants for re-thatching, Collyweston slating and stone wall repairs or other factors.

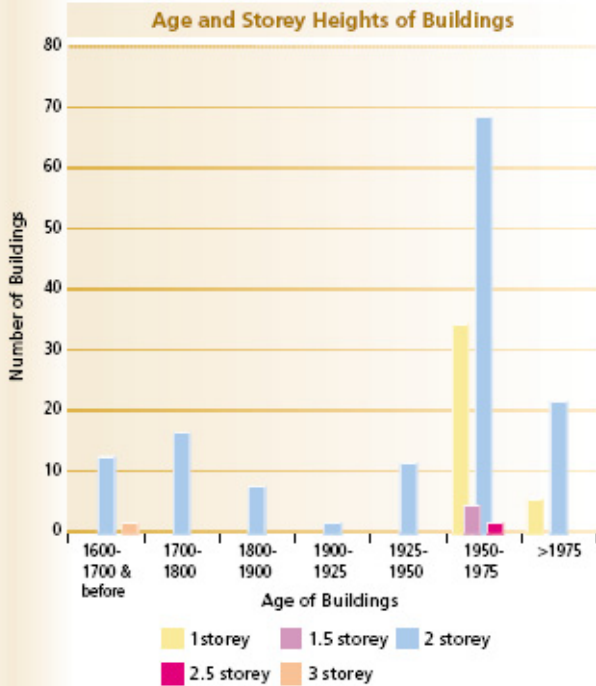
## Analysis by Age and Storey Heights

Most properties in Ailsworth are two storeys high and were built between 1950 and 1975. There is only one historic building in the village that has less than two storeys - a one and a half storey building that dates from 1600-1700. Up until 1950, bar this one exception, all the surviving property has two storeys. This begins to change in the 1950s, when single storey buildings appear in the village for the first time. Between 1950 and 1975, thirty four single storey properties were built, namely the bungalows in Singerfire Road/Casworth Way/Andrew Close/Main Street. The growth of single storey properties declined between 1975 and 2000, when only five were built. Recent years have seen infill development by houses between one and a half and two and a half storeys in height.

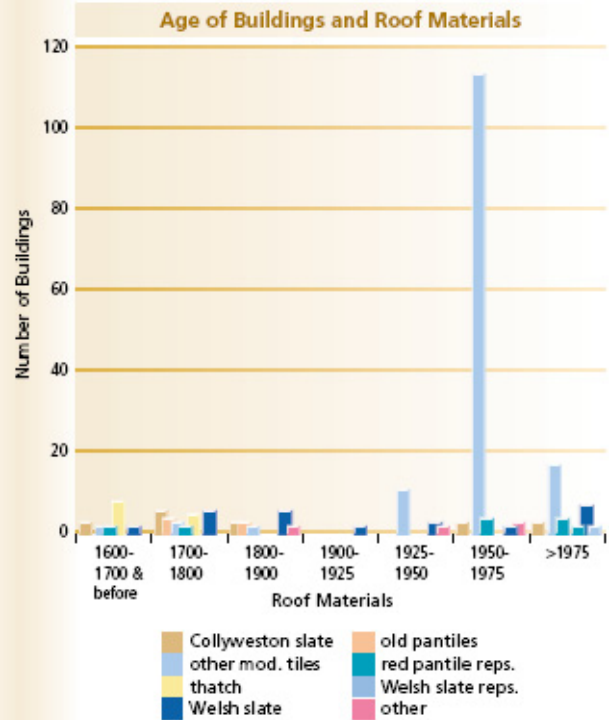
## Analysis by Age and Roof Materials

The palette of natural roofing materials in the pre-twentieth century period is very striking and the overwhelming preponderance of modern concrete tiles after 1925 even more so. It is interesting and encouraging to see the return of traditional materials since 1975, probably as a result of greater emphasis on conservation and design following the introduction of the Department of the Environment Circular 23/77, *Planning and the Historic Environment*.

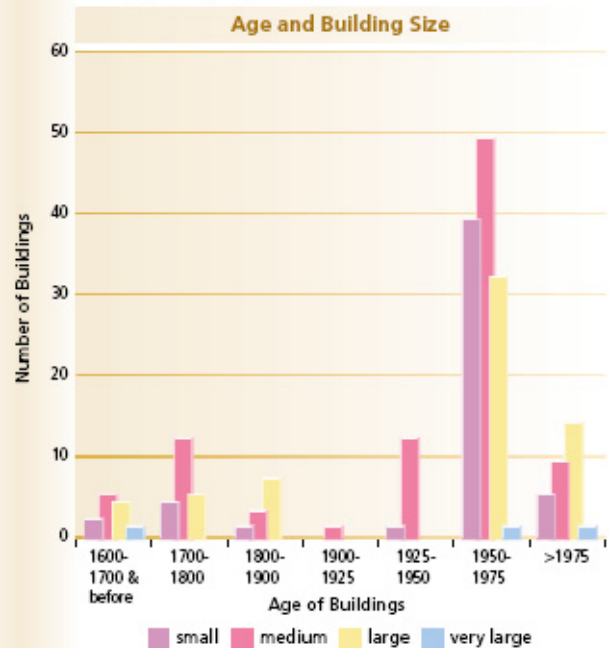
## Analysis by Age and Size

For the purpose of this graph, size is taken as the building footprint. The distribution of buildings clearly

shows the post 1950 building boom. Between 1950 and 2000, one hundred and fifty properties (of all sizes) were built in Ailsworth – the busiest period of construction by far.

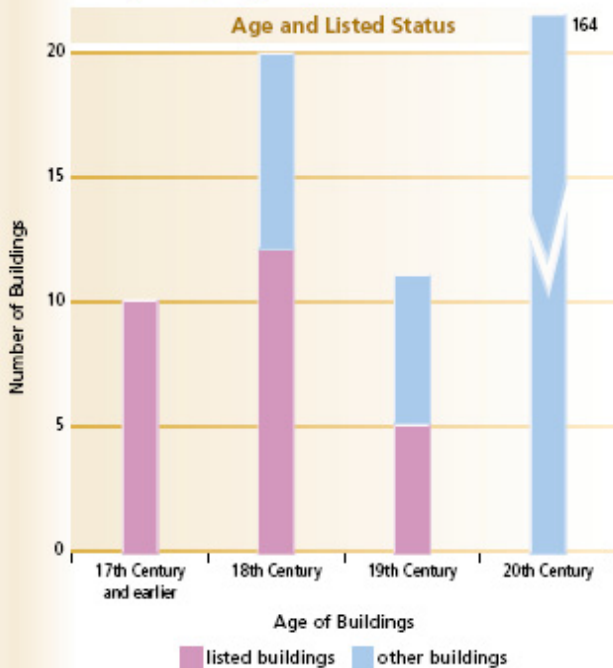
### Analysis by Age and Status

All buildings originating from the seventeenth century (1600-1700) are listed. Alterations to eighteenth century buildings have resulted in 40% not being justified to be of listable quality. Five of the 11 nineteenth century buildings have been listed for their group value; these are within the linked terraces on Peterborough Road. No twentieth century buildings are listed.

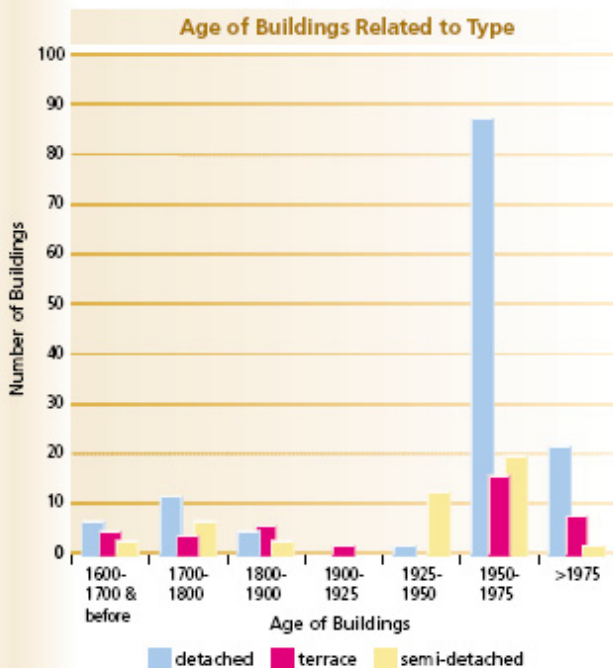
### Analysis by Age and Type

Until 1925, there was a mix of detached, semi-detached, end terrace and terraced properties. The 1925-1950 period saw the erection of twelve semi-detached properties, but the major expansion during the 1950-1975 period was primarily through the building of seventy seven new detached houses representing 37% of all buildings in the village.

The dominance of detached properties continues in the post 1975 period, when a further eighteen houses were constructed. Post 1950, detached houses represent 46% of all buildings in Ailsworth.

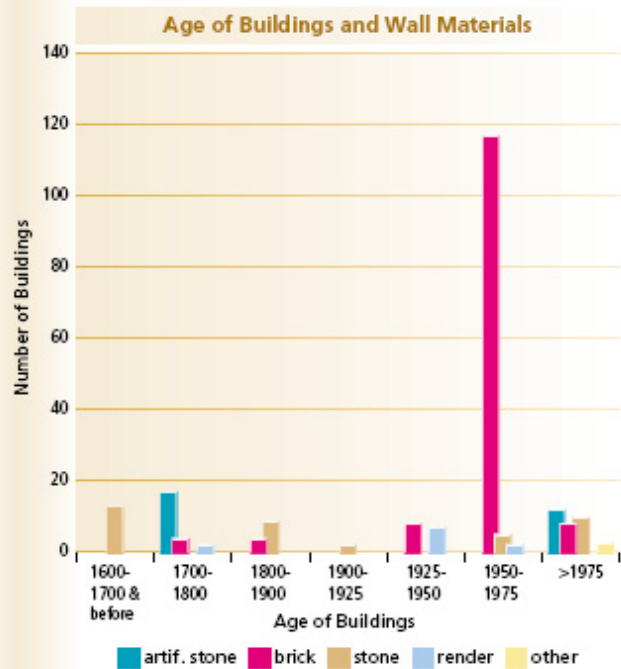
### Analysis by Age and Wall Materials

Until the twentieth century, stone was the predominant wall material in Ailsworth.

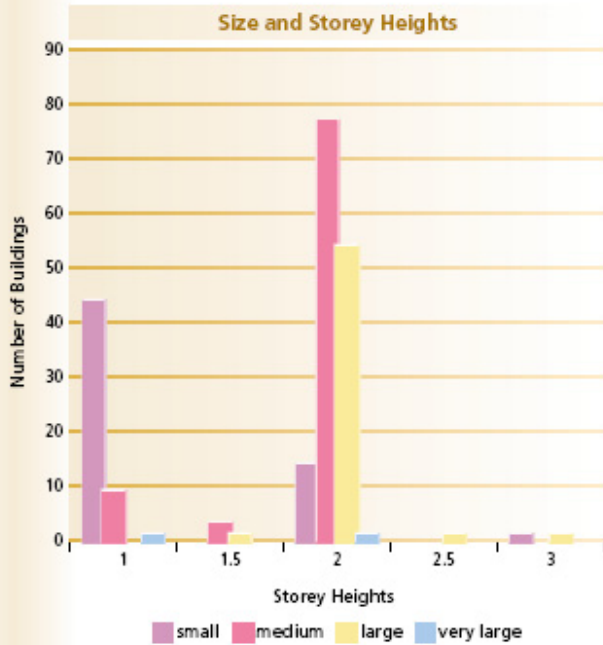
### Analysis by Building Size and Storey Heights

The analysis above confirms that medium sized two storey is by far the most dominant building form with small single storey buildings (bungalows on Casworth Way, Andrew Close, Singerfire Road and Helpston Road) the next largest group.

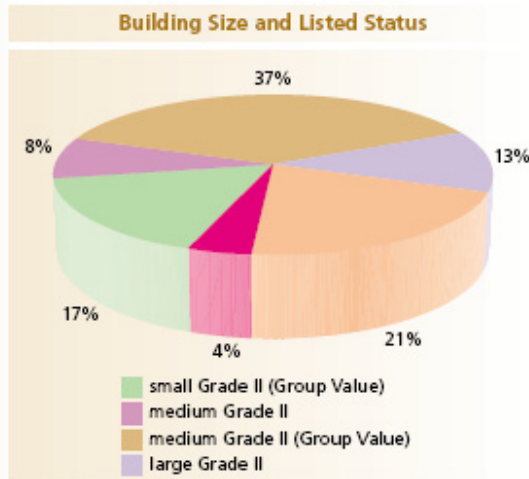
### Analysis by Size and Status

Nine (of twenty three) listed buildings have been recorded as medium sized, two are in the very large category and eight are recorded as large.

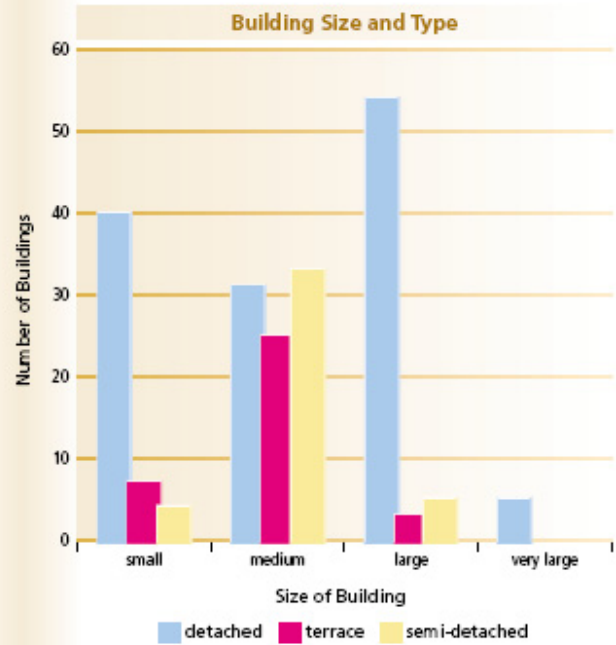
### Analysis by Size and Type

Most detached properties in Ailsworth are large, but there are a surprising number of very small and small, detached houses. Medium sized and small houses make up the majority of semi-detached and terraced properties.

Overall, Ailsworth has a far greater mixture of property sizes than neighbouring Castor, which is dominated by large detached buildings.

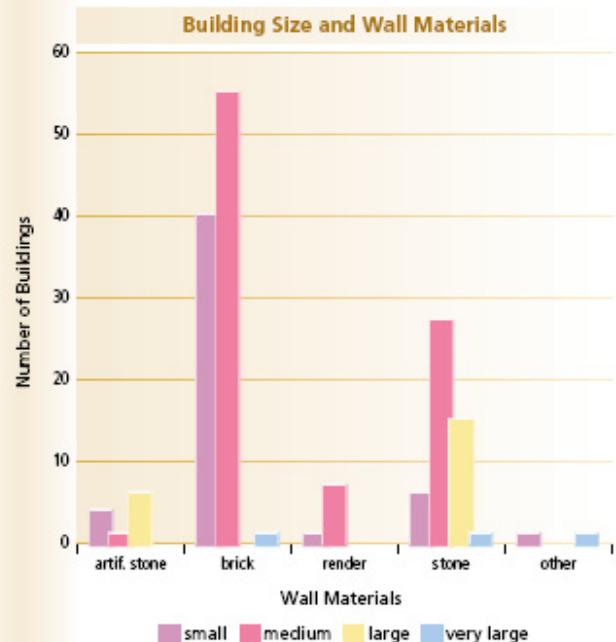
### Analysis by Size and Wall Materials

Forty one buildings (across all size divisions) are of stone. Of this total, by far the most stone buildings (twenty five) are medium sized. Large stone buildings are also well represented by nine buildings. Six stone buildings are small, twenty five are medium sized, nine are large and one is very large.

However, over half of all buildings are in modern brick and of these, twenty four are very small. There are eleven small properties, thirty four medium sized properties and thirty eight large brick properties.

Artificial stone has been used on only eleven properties (four very small properties, one medium sized property and six large properties). Old brick accounts for just one small property and three medium sized properties, while render is found on one small and six medium sized properties.

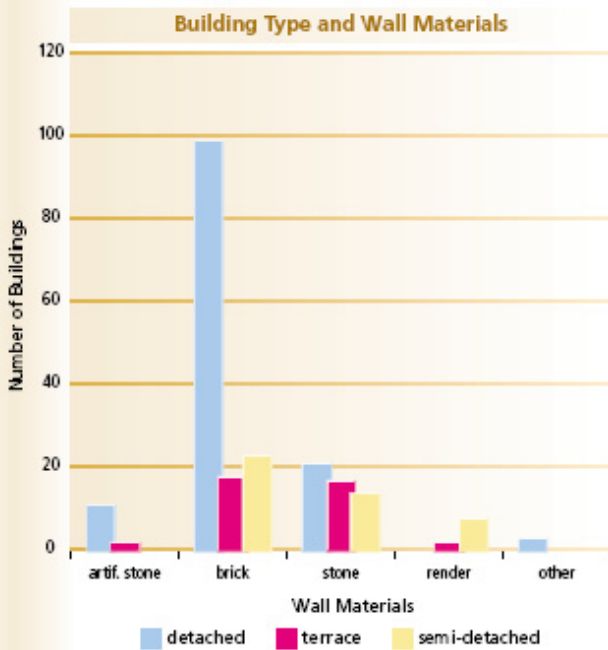
### Analysis by Type and Wall Materials

There are very few properties in Ailsworth that are not made either of modern bricks or stone. Of the few that are made of other materials, there are ten detached properties and one end terrace property made of artificial stone.

There are two detached properties built of old bricks, one end terrace and one mid terrace property made of this material.

However, it is modern brick that features most within the village built environment. Throughout the village, seventy eight detached, six end terrace, seven mid terrace and twelve semi-detached houses can be found. It can, therefore, be concluded that the majority of properties in the village are detached and built of modern brick.

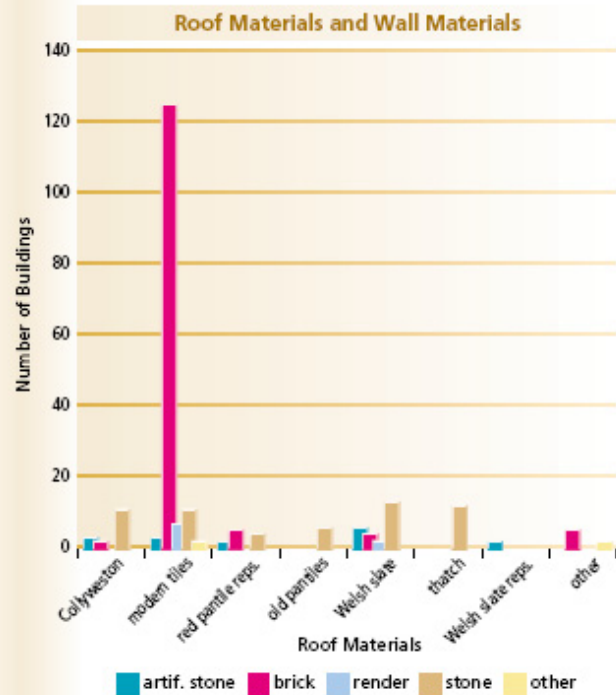
### Analysis by Roof Materials and Wall Materials

The overwhelming majority of properties in Ailsworth are built of modern brick and roofed with modern tiles. This combination of materials accounts for one hundred and twenty four properties in the village.

Stone properties with Collyweston slate roofs account for ten properties, while a further twelve stone properties have Welsh slate roofs. There are eleven stone properties with thatched roofs. Stone buildings with modern tiled roofs account for ten properties.

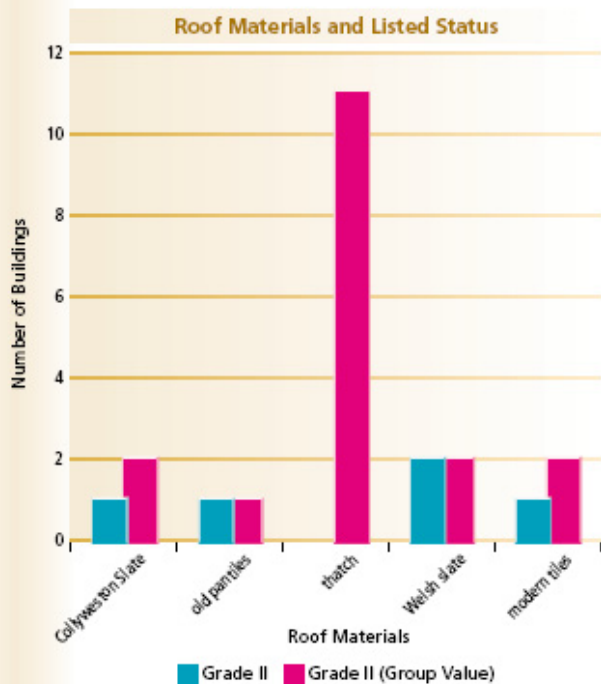
## Analysis by Roof Materials and Building Status

Thatch is the dominant historic roofing material in Ailsworth, present on eleven of twenty three buildings. Geographically, these are clustered in and around north Main Street and lend a small-scale vernacular character to this part of the village.

The Welsh slate buildings are mainly in a linked terrace along Peterborough Road, developed during the early part of the nineteenth century, presumably in response to increasing road traffic and trade.

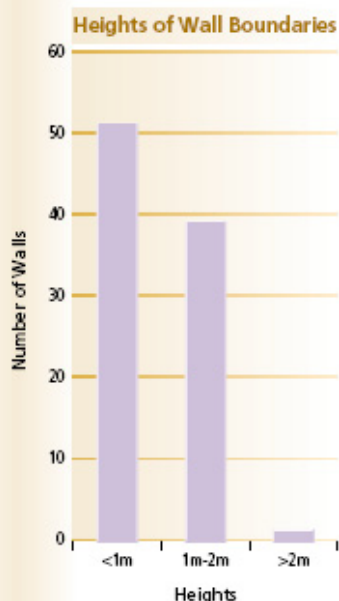
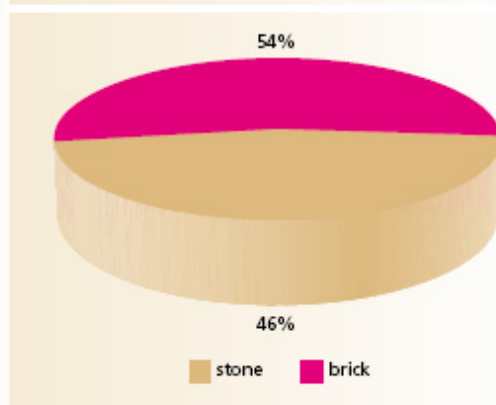
### Boundary Wall Materials

Almost half of all properties, ninety one in all, have a boundary to a public highway marked by a wall and 46% of all walls are made of stone and 52% are brick.

The actual number of stone walls which relate to properties is difficult to accurately assess, because some walls span several property boundaries but are relatively short, whilst others are very long, have a big visual impact and only relate to one property. In contrast, the brick walls in Singerfire Road/Casworth Way/Andrew Close are contemporary and related to the individual properties and their paths and drives.

Similarly, the village's stone walls need to be retained, kept in good repair and further breaches to create new access drives etc. strongly opposed. No new stone walls appear to have been built in the twentieth century. There are situations where new walls would enhance spatial enclosure or improve the townscape.

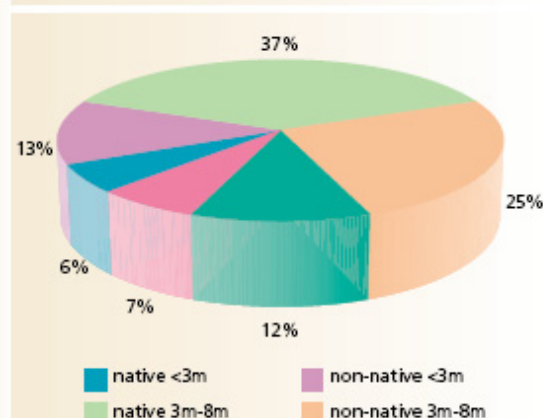
### Tree Types Related to Height

A total of three hundred and twelve trees are visible from public roads and footpaths. Over half 55%, are regarded as native species including oak, ash, hawthorn, poplar, birch, beech and horse chestnut.

The intuitive conclusion is that a stock of young trees, which will grow to over 8m in height and eventually replace existing large trees, have not been planted.

A number of key trees are at or approaching maturity. It would make sense to plan and act now to firstly, replace trees which are now at maturity and secondly, to consider areas of less positive townscape where space

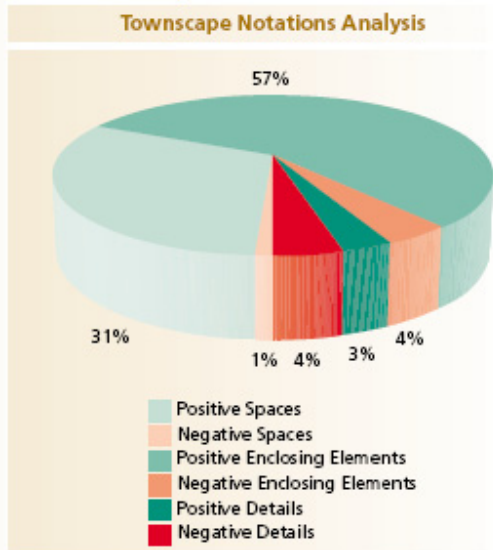
### 5.3.1 General Analysis

The townscape of Ailsworth is overwhelmingly positive. A total of one hundred and eighteen positive and only twelve negative townscape contributions were recorded, with a breakdown as follows:

The table right provides a detailed record of the relative contributions of each element of townscape. It gives an indication of the relationship between dynamic and static spaces, with further spatial definition provided by vertical enclosures and changes in level.
